REPORT OF INVESTIGATIONS
No. 23

GEOLOGY
OF THE
CROW CREEK DAM SITE

By
E. P. Rothrock

October, 1934

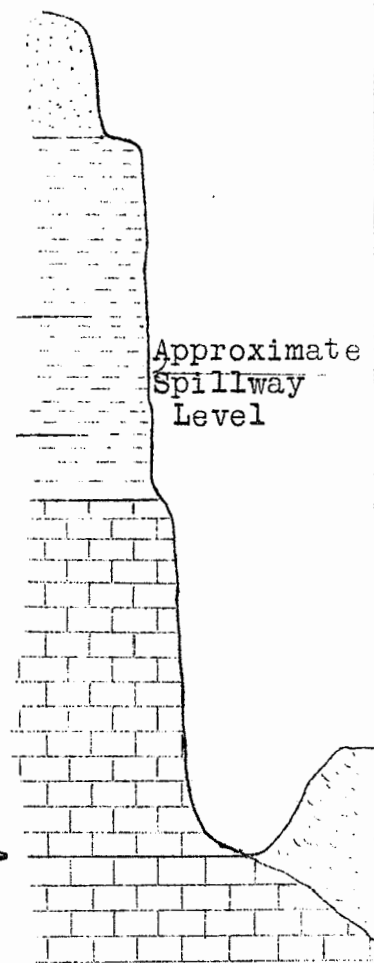
Section on East Bluff of Crow Creek
200 feet North of Dam Site

Feet

8-10 Gravel

15 Shale. Gravel cover

10 Shale covered. Much gravel strewn on surface

5 Black Shale

30 Chalk

Water level in Crow Creek

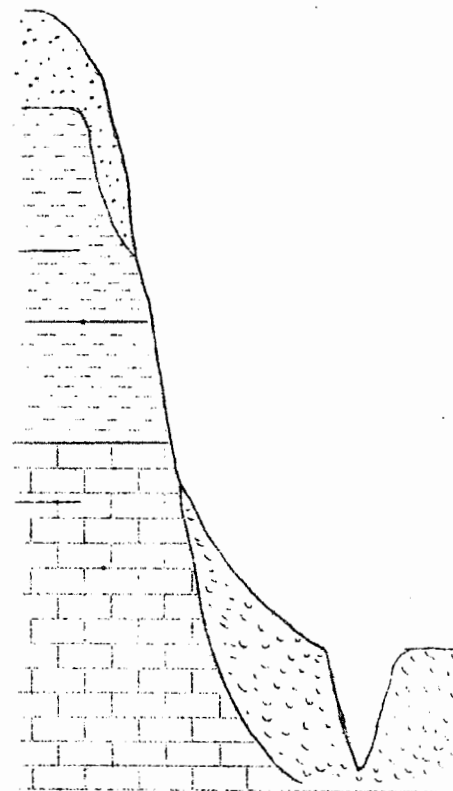
Section on East Bluff of Crow Creek

Feet	
15-20	Covered. Gravel littered surface may be underlain with Shale. (Top of Shale 50' above base of this section in next valley South)
6	Black Shale, $\frac{1}{2}$ -1 inch Bentonite streak in the bottom
10	Black Shale
5	Weathered Chalk
23	Alluvium to the Water level in Crow Creek

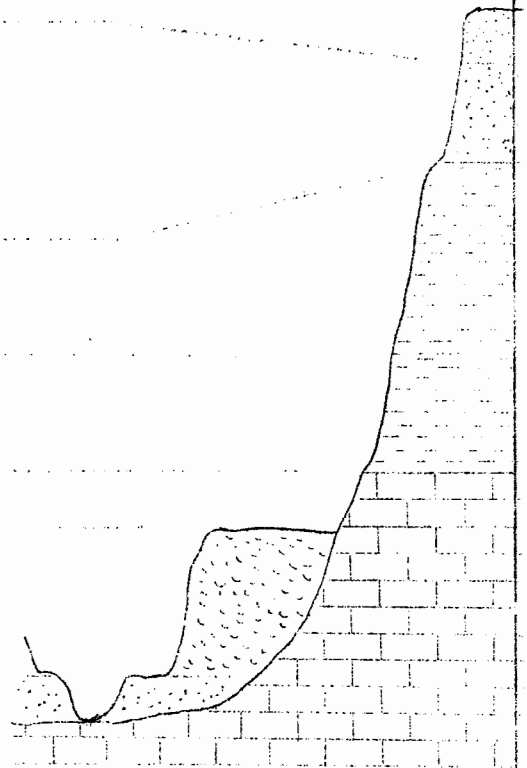
Section on West Bluff of Crow Creek

Exposure made by digging for core of Dam

- 3-4 Silt Cover
- 8 Gravel and sand, upper half fine medium sand, lower half coarse gravel pebbles 2-6" in diameter mixed with finer gravel and sand. Much red color due to oxidized iron
- 16 Black Shale, heavy and sticky typical "fish scale zone" shale
- 10 Calcareous grey shale
- 5 Chalky Alluvium
- 12 Heavy Clay Alluvium with lenses of coarse dirty gravel
- 4 Coarse Gravel, giving much water which contains: wood, clam shells, and mammal teeth in the bottom. Bottom foot or so is stiff sandy muck with many black streaks. Evidently an old swamp
- Chalk rock exposed in the bottom of the hole

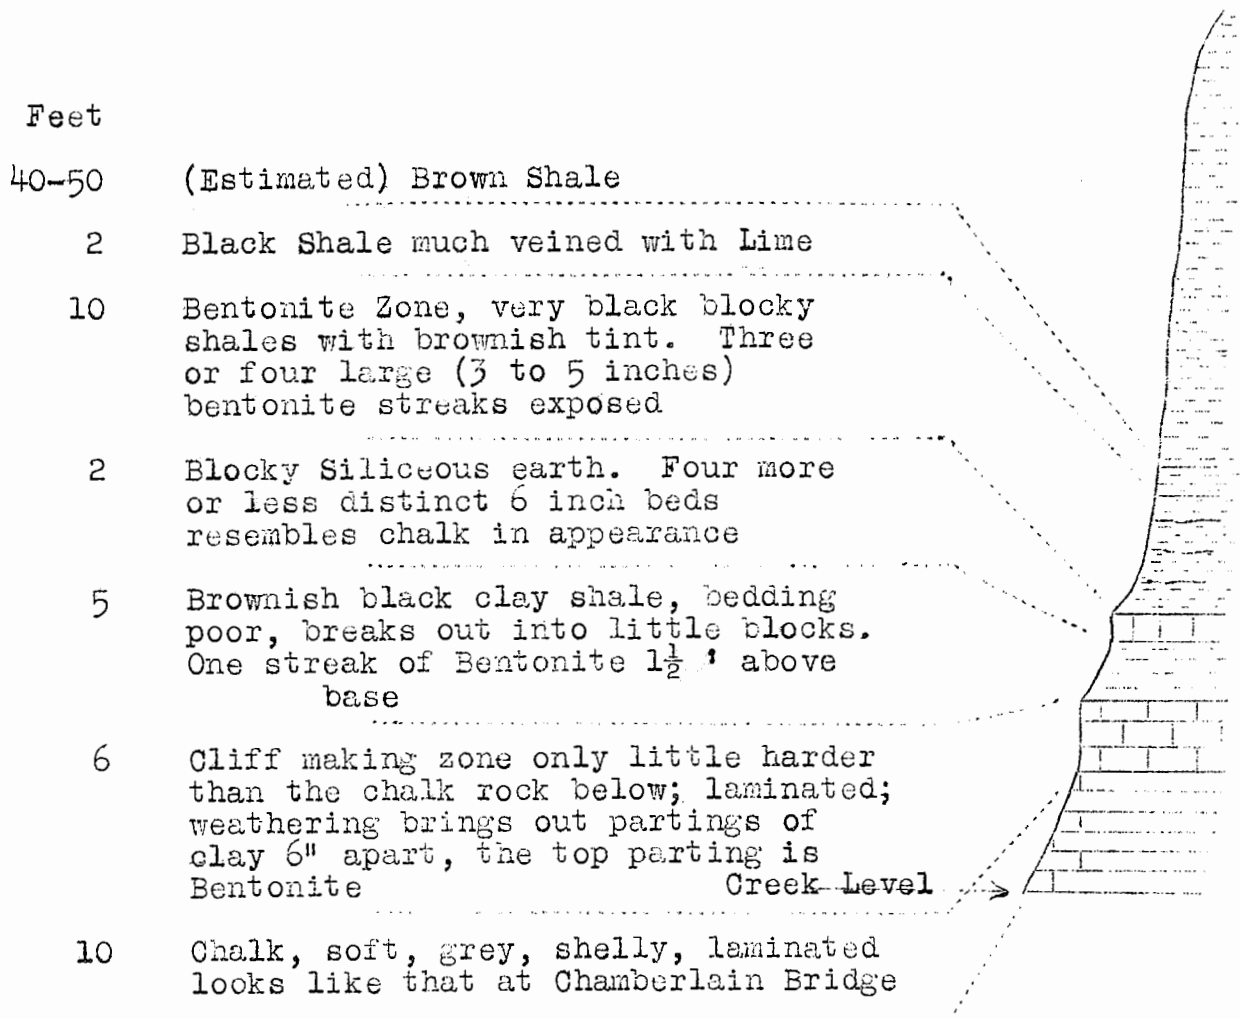
Section on West Bluff of Crow Creek

Good exposure due to undercutting by Crow Creek
