PROCEEDINGS

HOMESTAKE'S GRIZZLY GULCH TAILINGS DISPOSAL PROJECT

Mark C. Carrigan - Dames & Moore
David R. Shaddrick - Homestake Mining Company

Homestake Mining Company's \$12.2 million tailings disposal project is one of the mining industry's most significant environmental projects. This paper describes the role of geological engineering in the location, design, and construction of the dam.

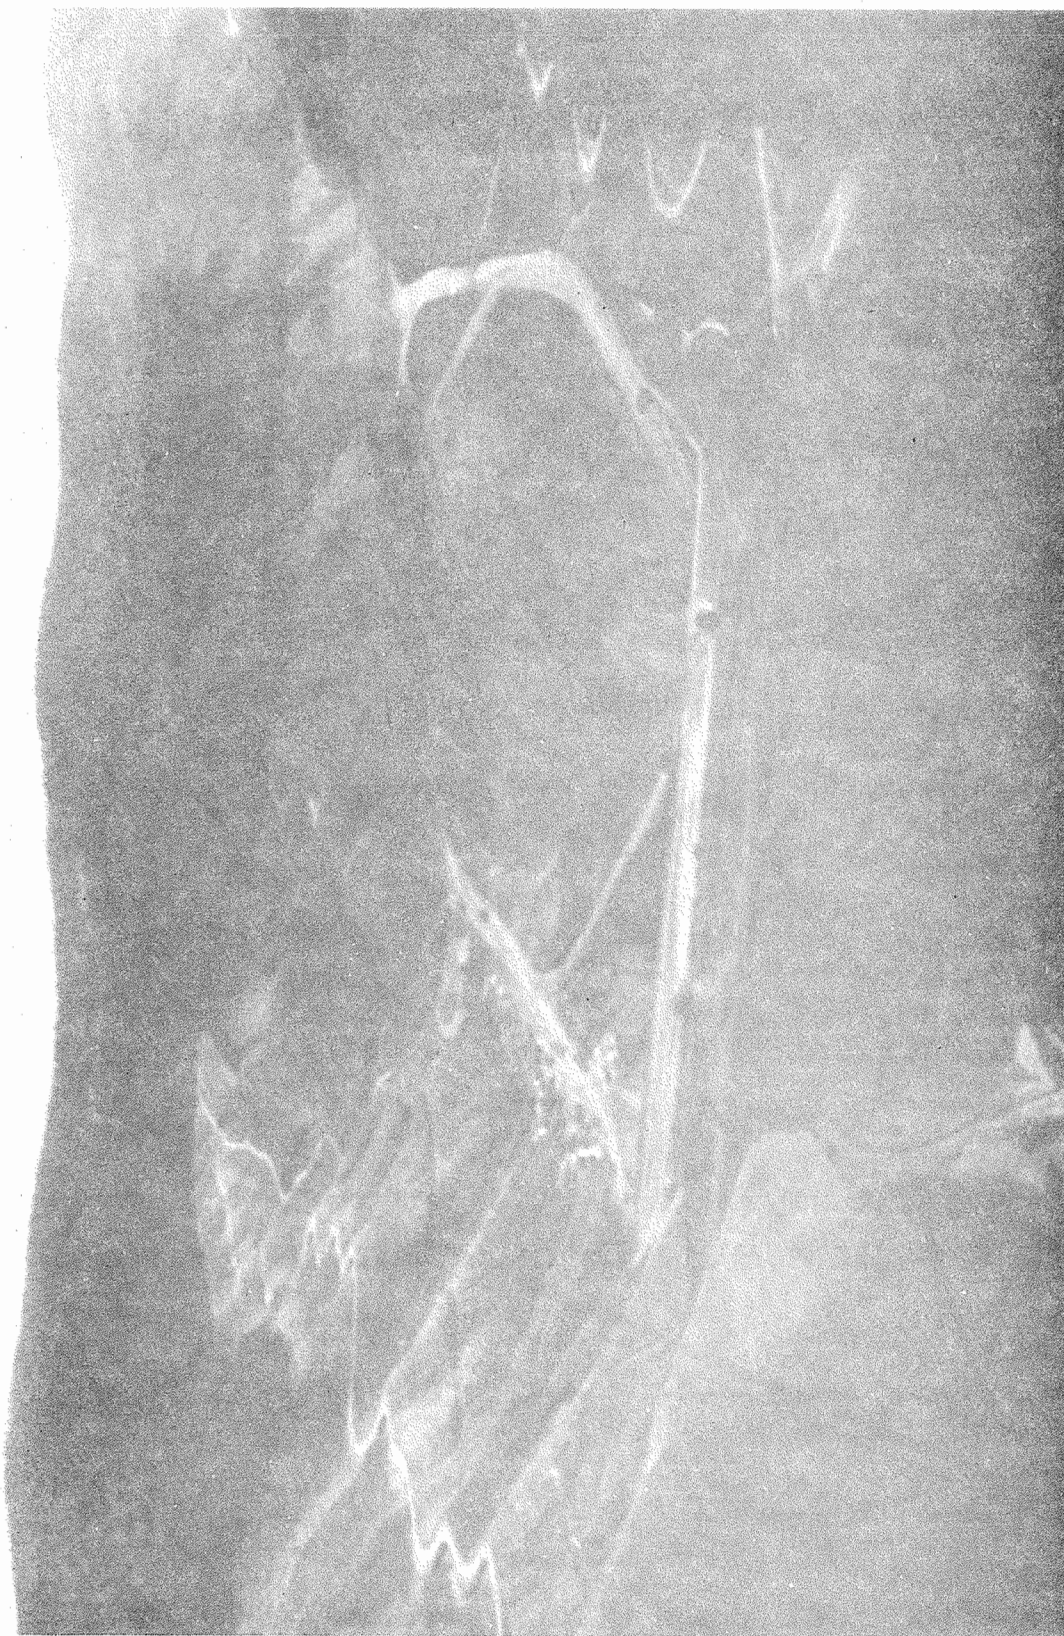
Figure 10. Aerial of Dam. (under construction)

Work on the project actually got underway in March, 1976, and is scheduled to be completed in the fall of 1977. Upon completion the Grizzly Gulch Tailings Disposal Project will provide an environmentally safe repository for Homestake's tailings for decades to come, and it may well provide a model for other firms with similar waste disposal problems (Figure 10).

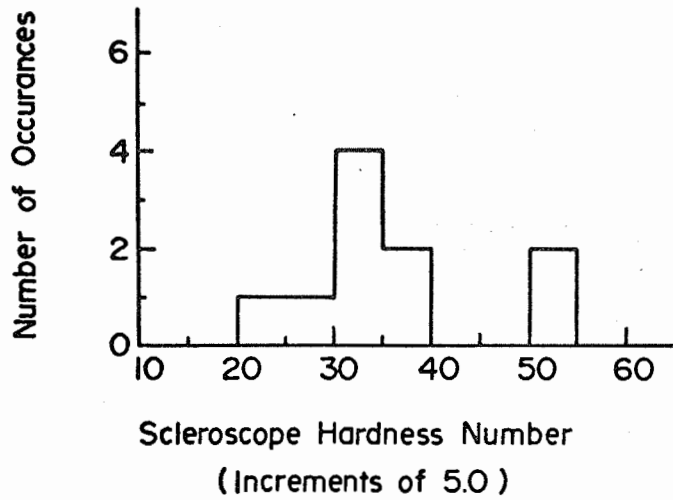
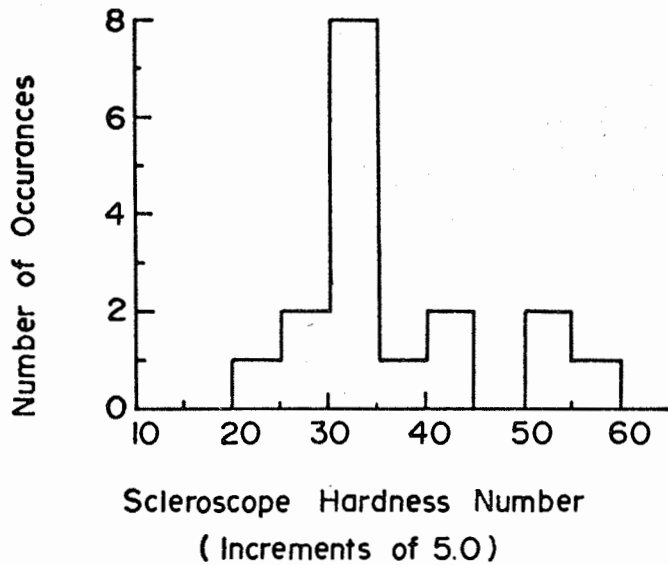
a) Calculated Results of Significant Correlations

b) Actual Test Results

FIGURE 4 FREQUENCY DISTRIBUTION BAR GRAPHS FOR SCLEROSCOPE TEST ON OVEN DRIED SAMPLES OF VARIOUS SHALES.

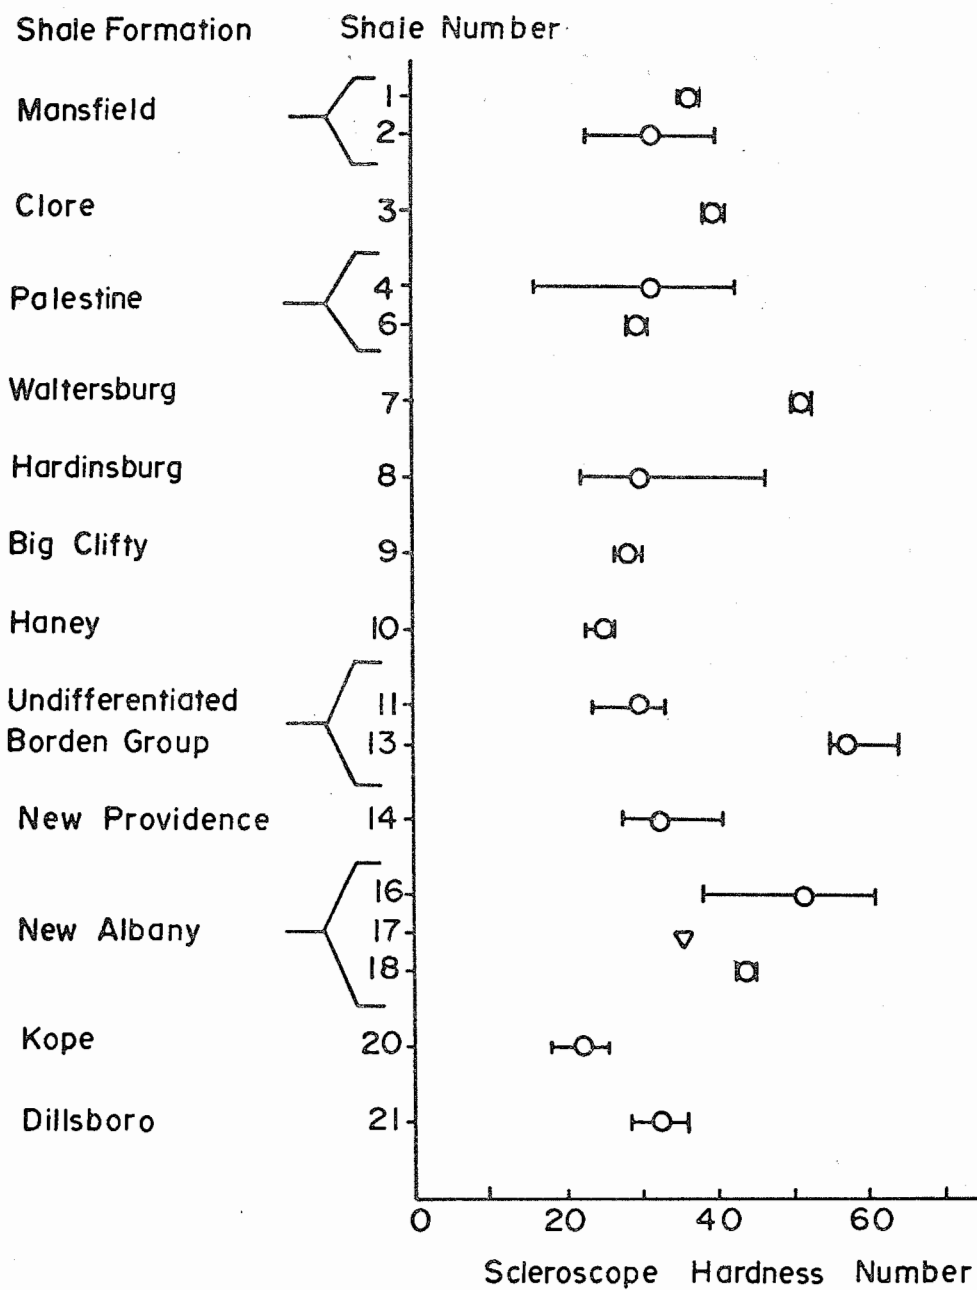
○ Indicates Mean Value
 — Indicates Range of Values Measured
 ▽ Indicates Only One Value Observed

FIGURE 5 AVERAGE VALUES AND RANGE OF SCLEROSCOPE HARDNESS FOR VARIOUS SHALES AT ZERO MOISTURE CONTENT.

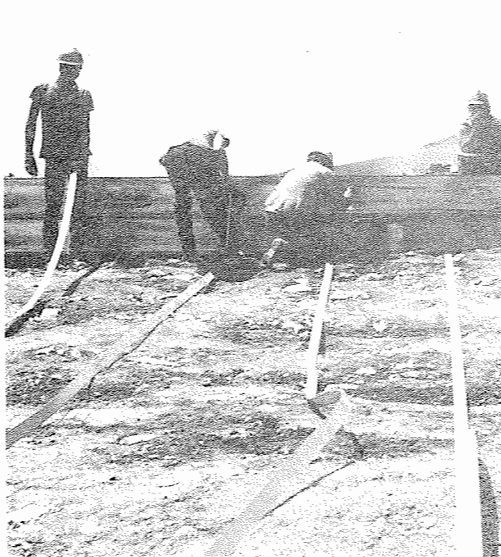
Photo 6. Attaching reinforcing elements to 13 inch face "skins".

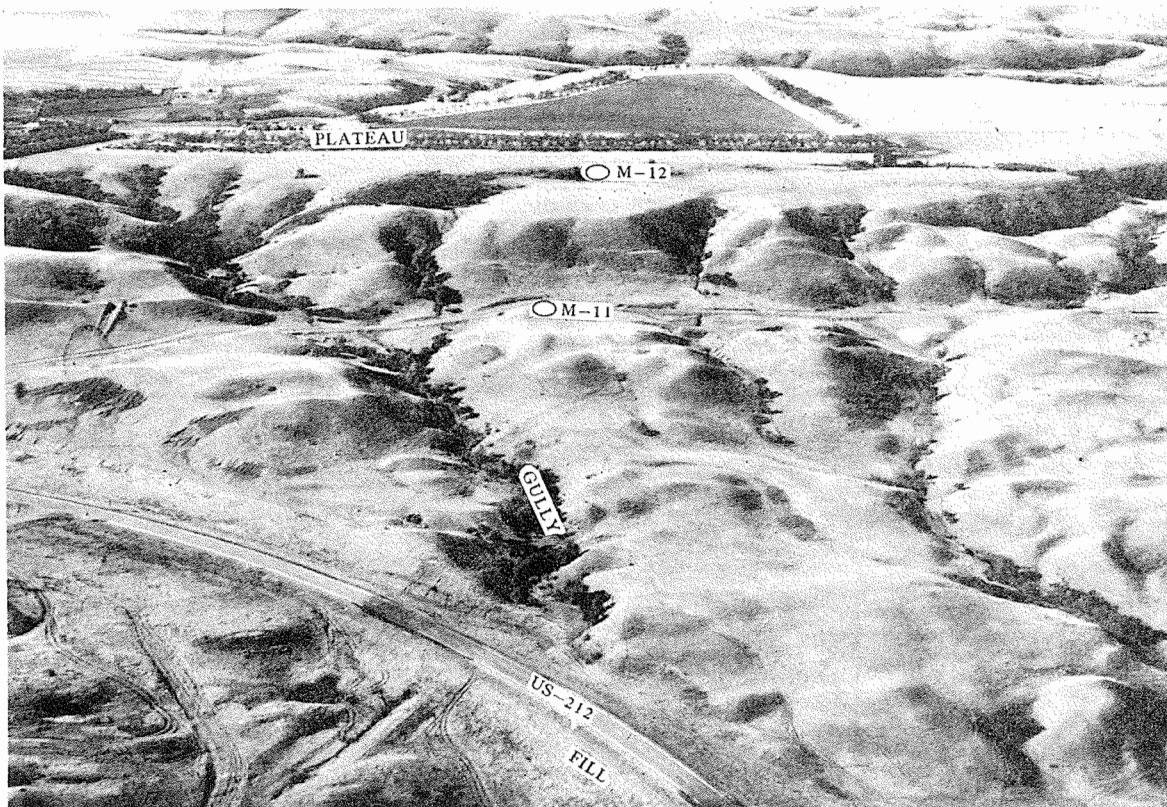
Figure 4. Oblique photograph of back scarp area, looking south, 1962.

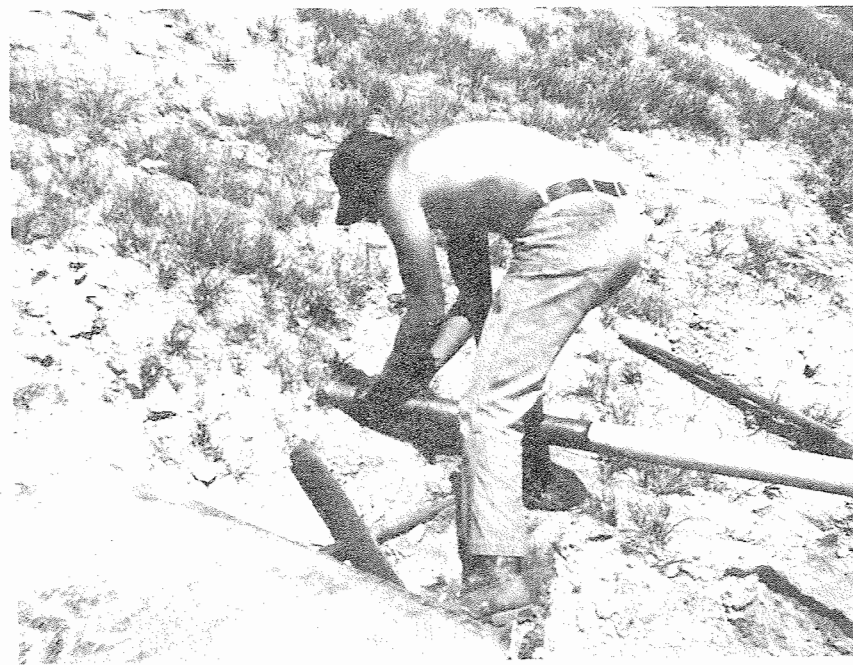
Figure 4. Air hammer on the end of the drill rod is being positioned to start a hole.

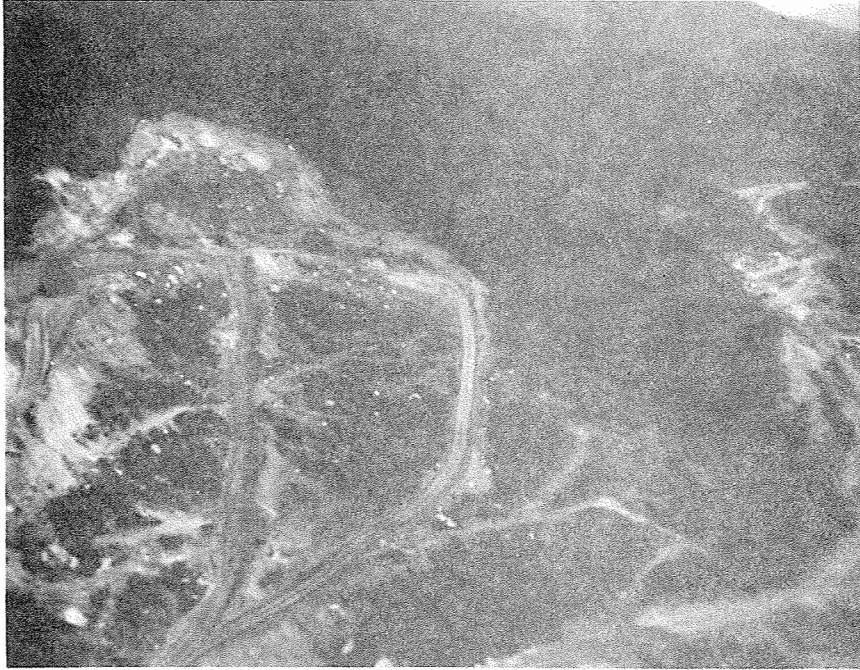
Figure 8. Slide Area 3 as the upper slope is started. Although staked 3/4:1, it was expected to fall back to a stable plane.

retaining structures. At this point it was decided to begin cutting high on the mountainside on a slope which generally conformed to the slope on rock cliffs above. Although staked on 3/4:1, this slope was expected to fall back to a stable rock plane. After this decision was reached it became a matter of simple, but large-scale excavation, extending at one point, nearly 1,000 feet right of the centerline. When a satisfactory plan was reached, a wide interceptor bench was left and a much flatter slope extended on to grade. Thus, of all alternatives considered in Slide Area 3, slope flattening proved to be the most effective (Figure 8).

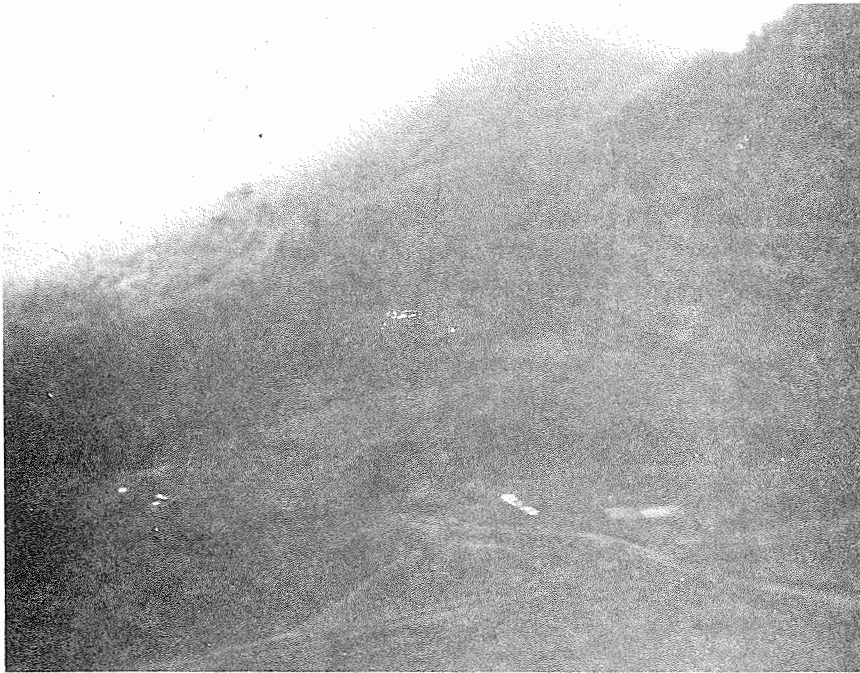
Figure 12. Construction of the counterweight at the toe of Slide Area 7. Tower is about 50 feet behind the slide.

To contain this slide mass, the Y-line was relocated and a counterweight constructed on the abandoned Y-line roadway (Figure 12). Horizontal drains were installed in the toe of the counterweight and into natural ground above it, though they produced little water. It was recommended that the steel transmission tower be moved to another location, but this was never done. Slope inclinometers installed at the base of the tower and in the counterweight have detected no movement since the work was completed.

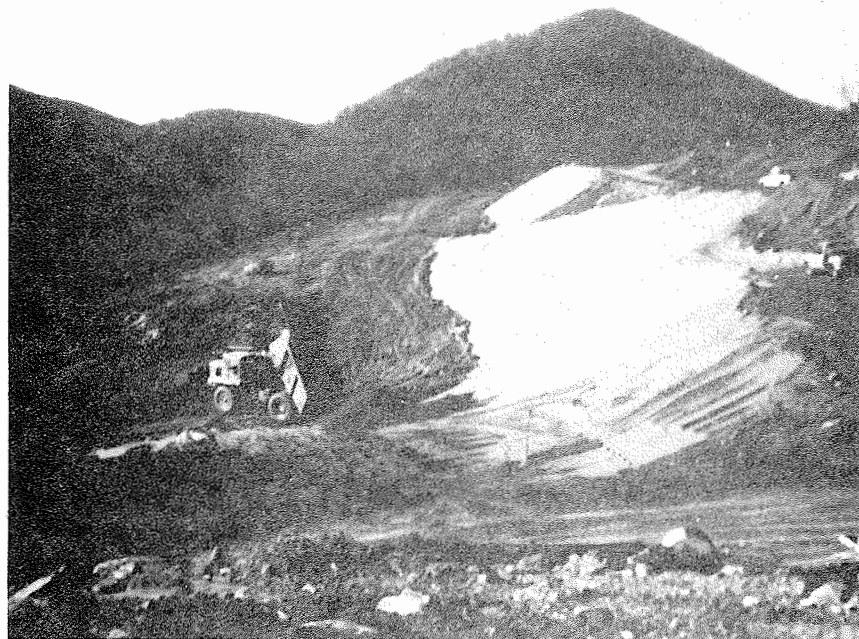
Figure 15. Embankment material being placed over sand and stone blanket. Lighter material is stone; the darker, sand.

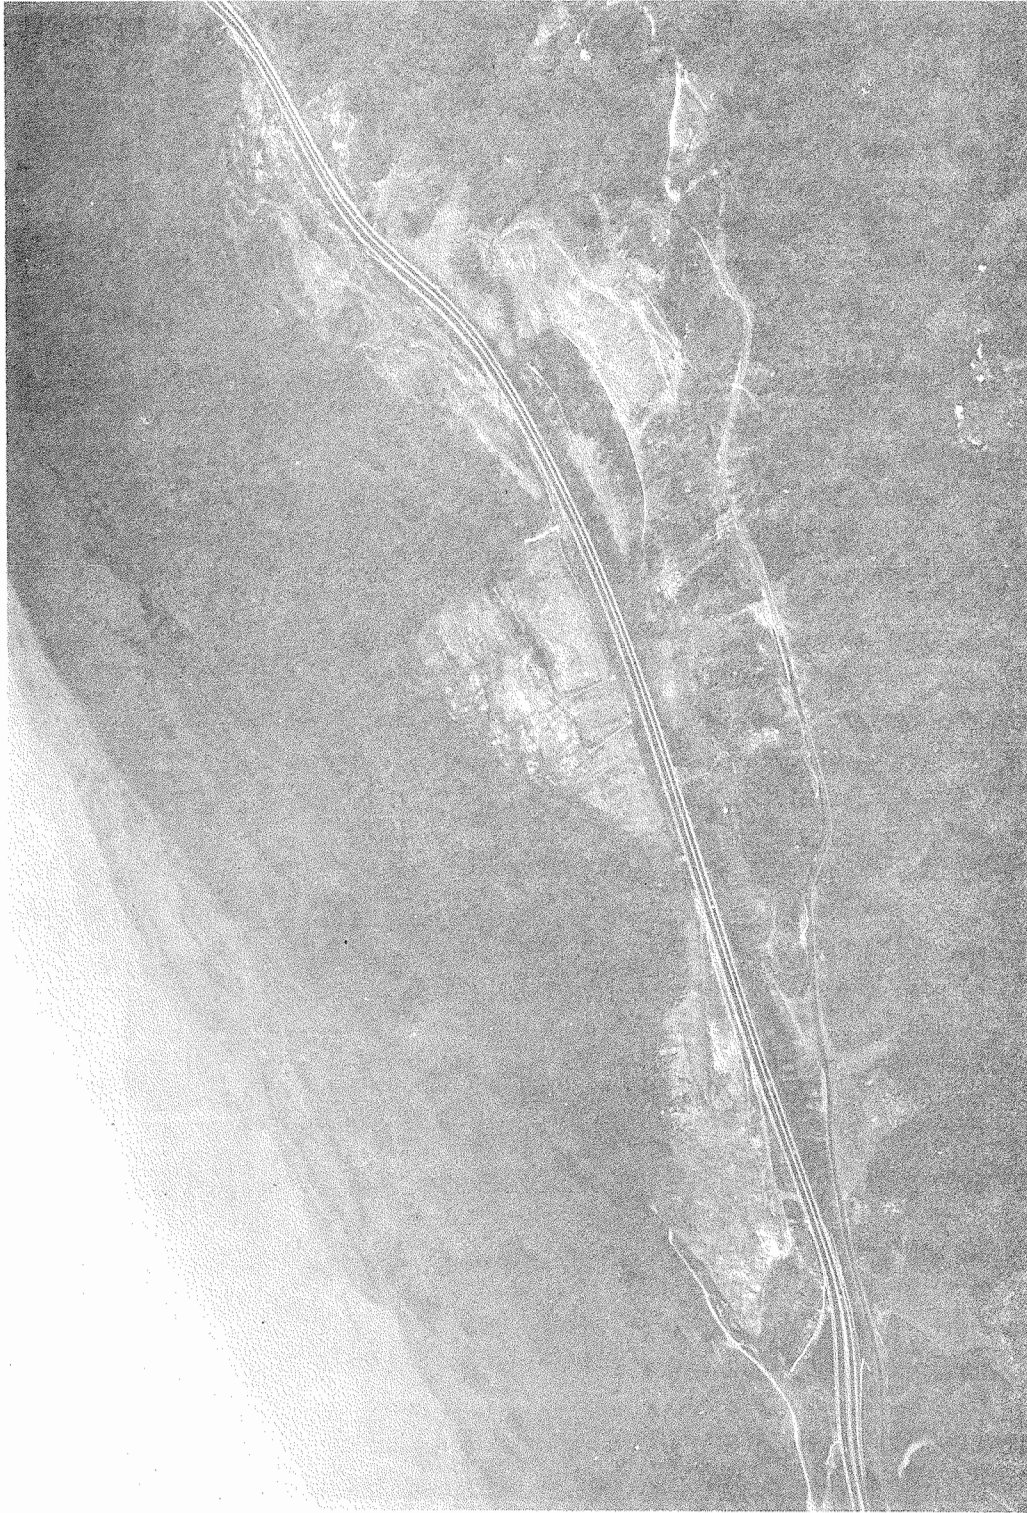
Figure 16. Interstate 26 Slide Area, May, 1977.

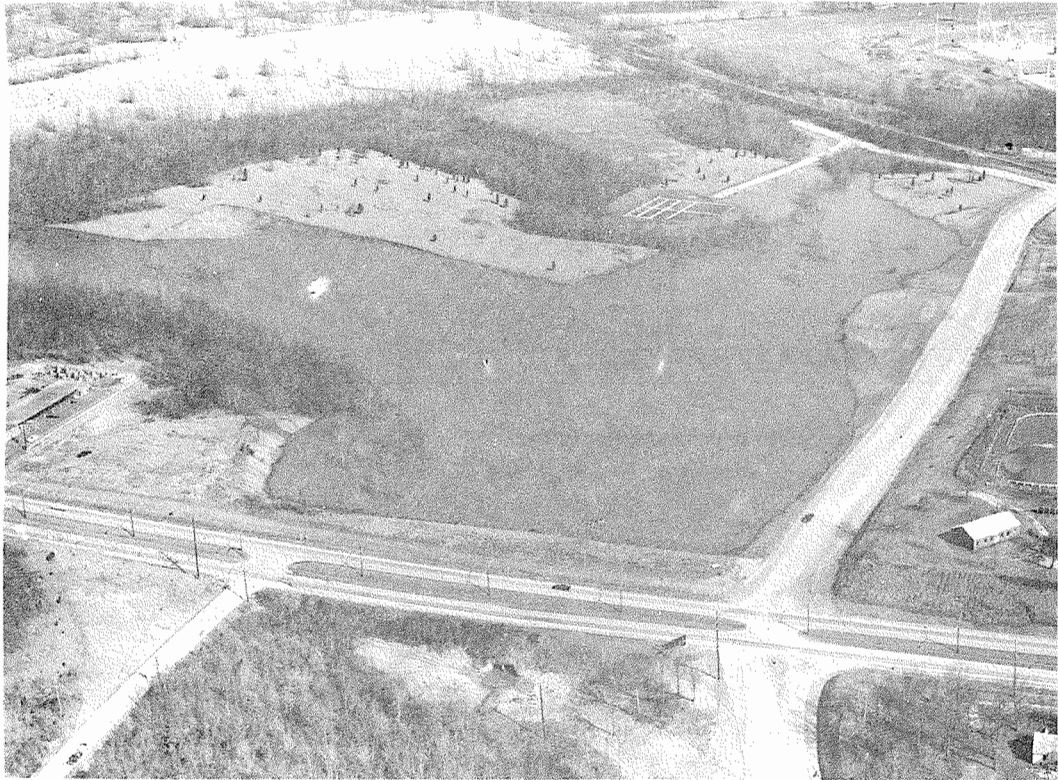
Figure 5. Aerial View of State Route #1 Horizontal Drain Project. (Note outlet end of Box Culvert in lower part of photo.)

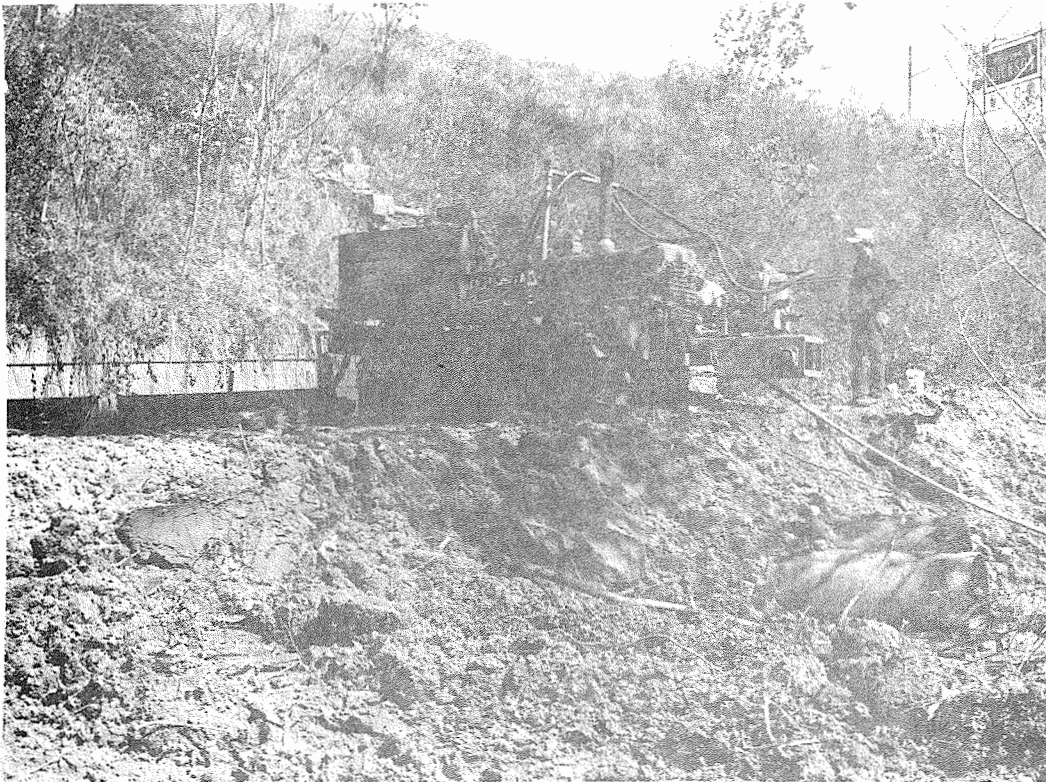
Figure 10. A Temporary Earth Fill had to be Constructed in order to Drill the Line of Holes Across the Top of the Culvert.

A 1.2 m to 1.8 m (4' to 6') temporary earth fill had to be constructed across the drainage area at the outlet end of the culvert in order to reach the holes across the top (Figure 10). Drag bits were used to penetrate the cherty clay materials that made up the embankment. Rock bits were used to drill through the wing walls for the side holes. The holes along the top of the box were drilled with little or no slope, and the side holes were drilled with about 5% slope. Penetration rates were very high due to the softness of the clay and the many voids that had developed because of erosion along the top and sides of the culvert. A two-man drill crew using a single rig completed the drilling in approximately twelve days, for an average of about 91 m to 96 m (300' to 315') per 8-hour day. This included two or three moves and setups per day.

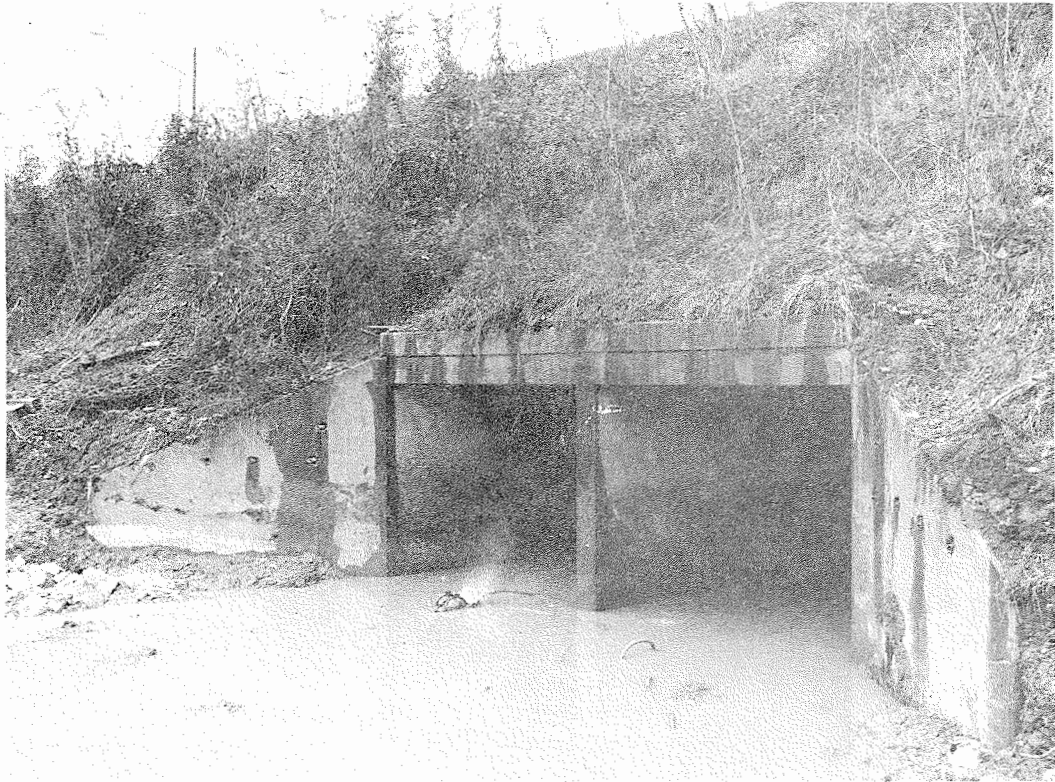
Figure 11. View of the Culvert After Completion of Drilling. Note Drains protruding from the wing walls and along the top of the Box.

Because of the fine-grained materials in the embankment, slot openings of .25 mm (.010") to .51 mm (.020") were used. Figure 11 is a view of the outlet end of the culvert after completion of the drilling, which, as planned, was finished prior to installing the liner. Twenty-five of the 31 drains were moderately active (less than .0006 liters/sec (.01 gpm) to .01 liters/sec (.08 gpm) 24 hours after completion. All of these have remained active to some degree since completion of the project. It is

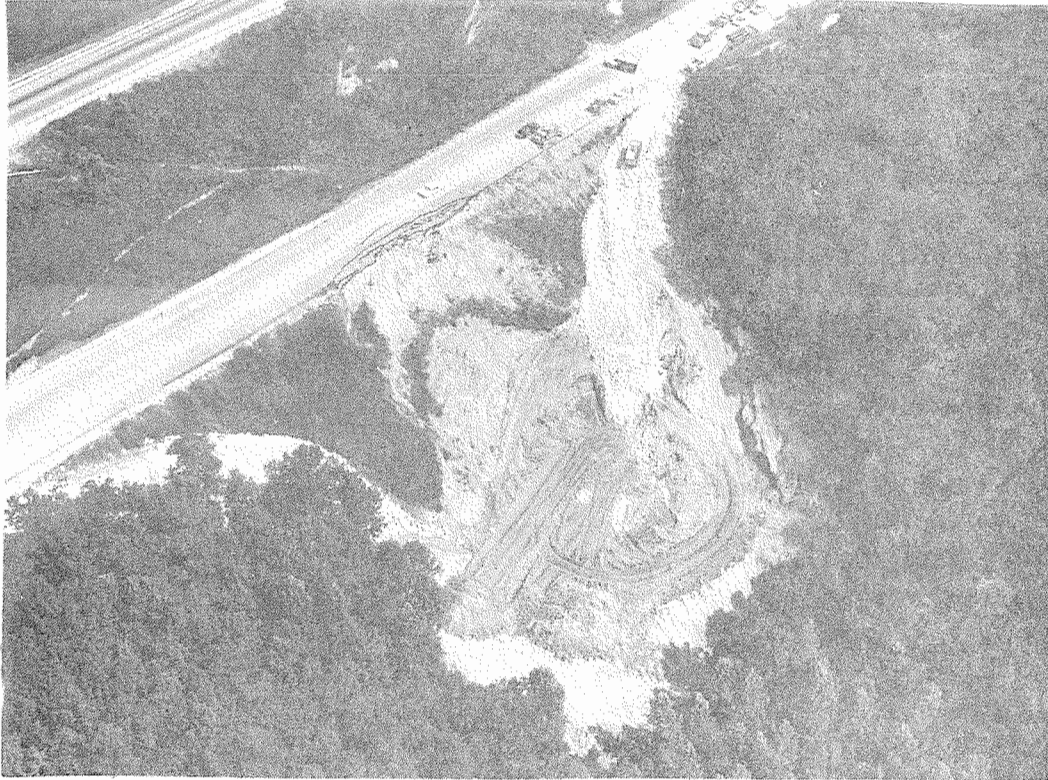
Figure 13. View of the 1464+00 slide along I-75 in Campbell County.

in the roadway continued to develop as each segment or unit of the slide was removed. To stop or at least reduce this movement, it was determined that the flanks of the slide had to be buttressed before excavation could proceed (Figure 13). Once the flanks were stabilized, the failed material was removed without further upslope movement. Two levels of horizontal drains were installed on 6 m (20') centers, separated in elevation by 7.6 m (25'). The 13 holes on this particular slide penetrated to depths between 53 m and 61 m (175' and 200'). All were drilled on 5% slopes. As the drillings in the lower level were completed, the construction of the buttress proceeded. The drains were encased in 152 mm (6") corrugated metal pipe and extended through the buttress prior to building the buttress to the next drainage level (Figure 14). All drains in this slide (1464+00) were quite active initially, with flows up to .25 liters/sec (4 gpm) in at least half the drains. Figures 15, 16, and 17 depict conditions prior to the slide, after failure, and after repair.

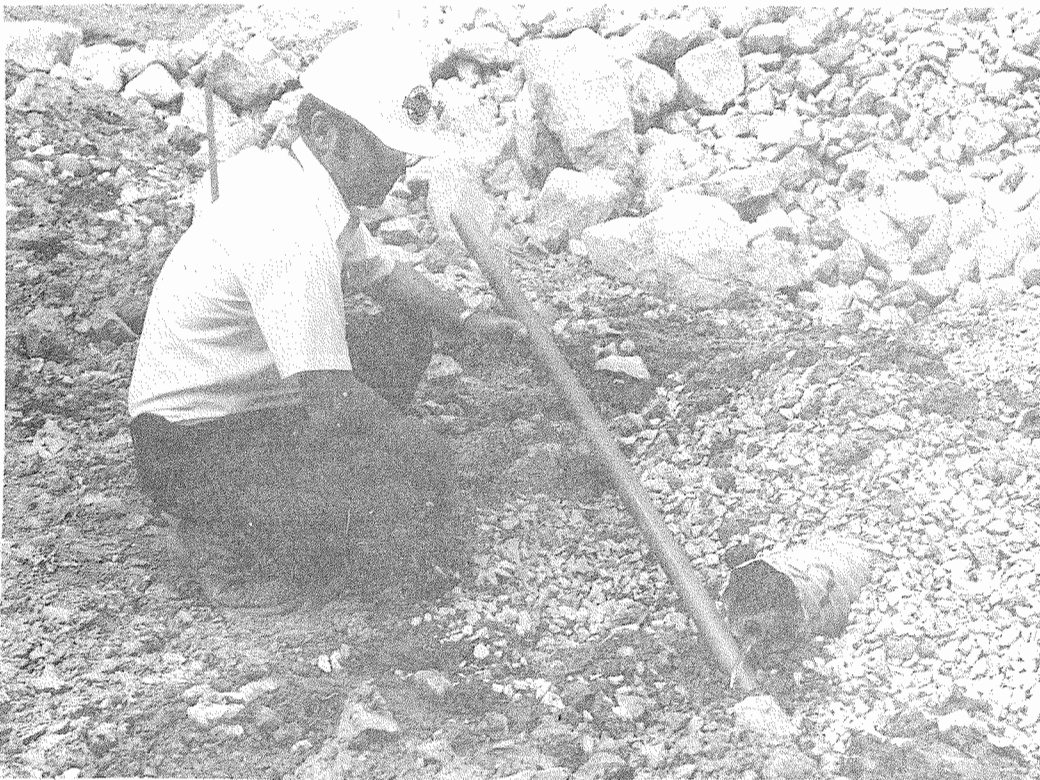
Figure 14. Water issuing from a Horizontal Drain installed in the 1464+00 slide.

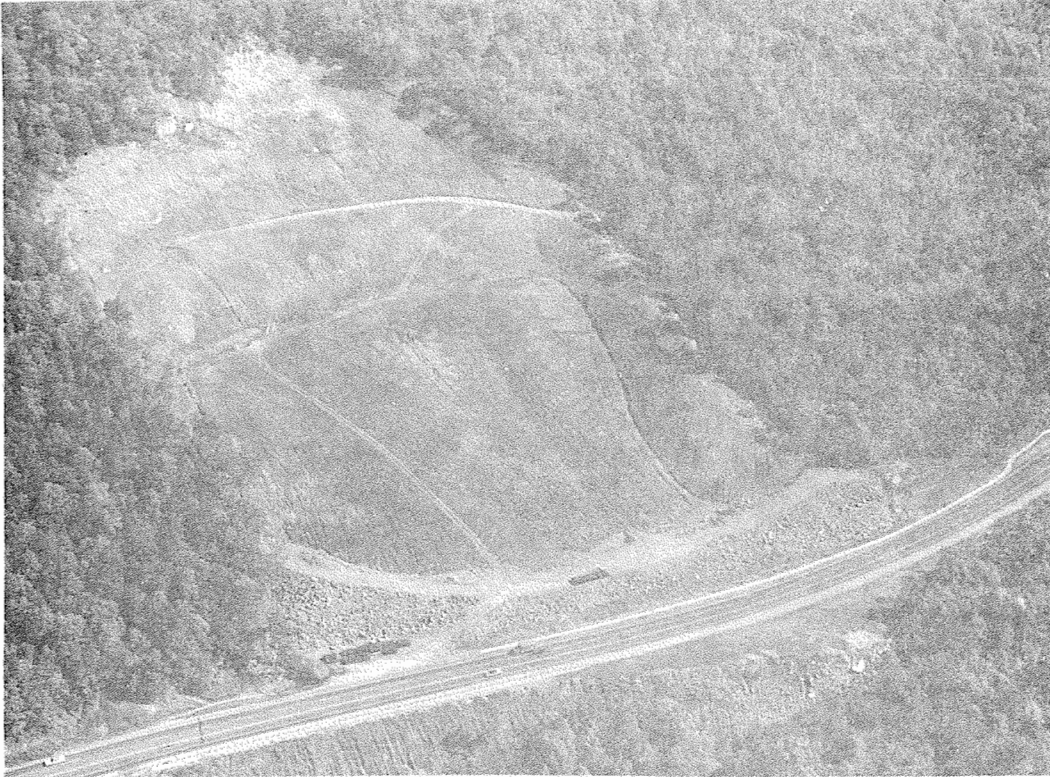
Figure 23. Aerial View of Repaired Slide #8 Along I-40 at Rockwood (see Figure 22).

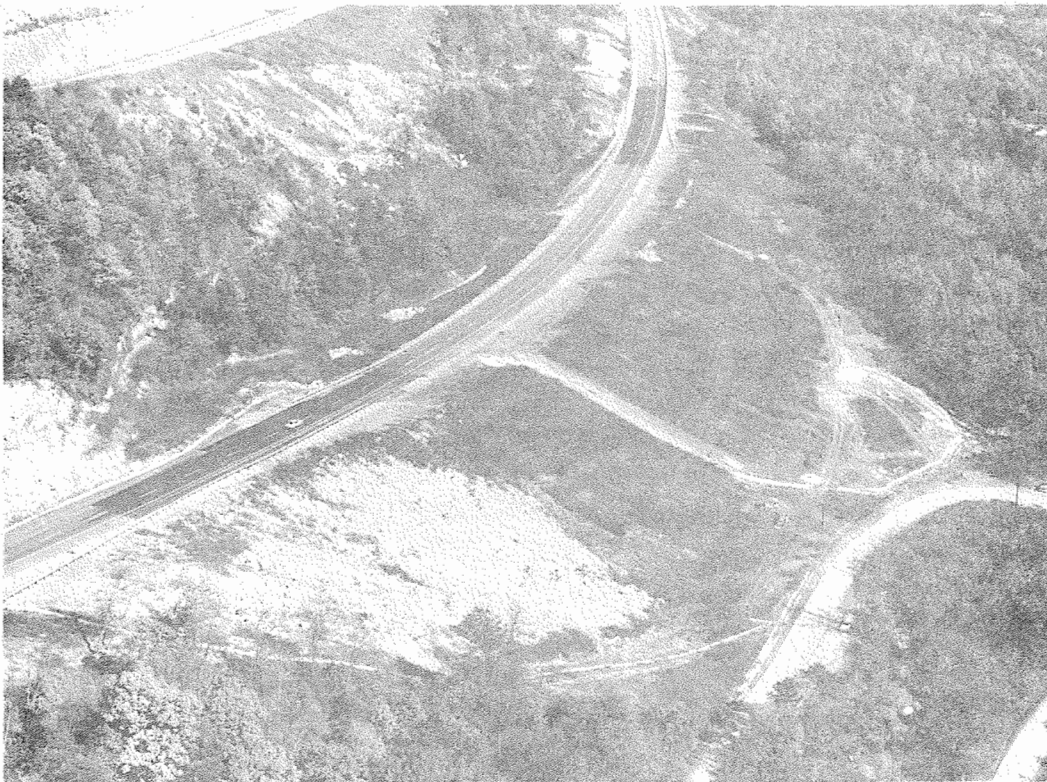
Figure 24. The 2003+00-2018+00 Fill Slide at Rockwood. Newly paved areas on each end of the embankment delineate the lateral limits of the slide.

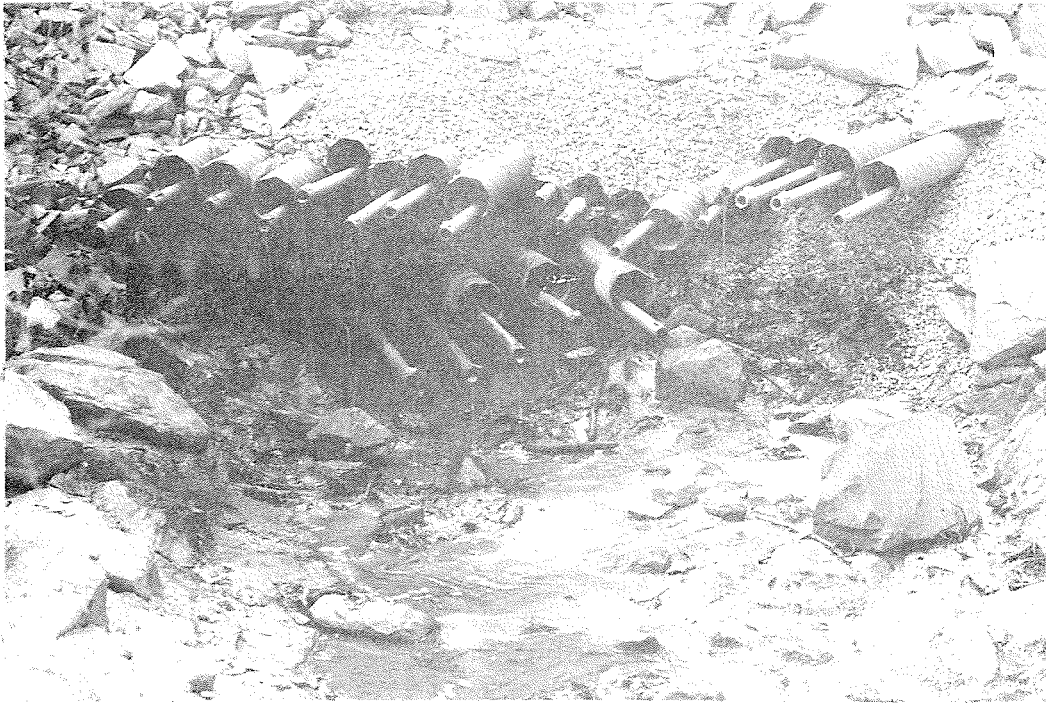
Figure 26. Horizontal Drain Installation at Rockwood (see Pad "B", Figure 25).

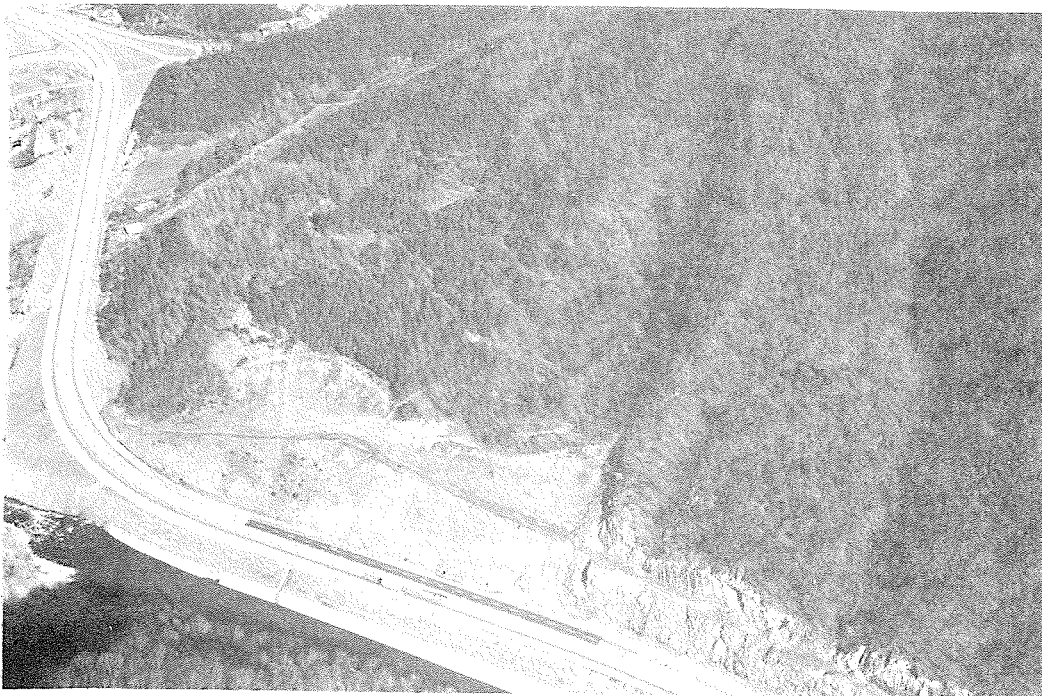
Figure 27. Aerial View of the Hartford Slide.

through the trough toward the river. During periods of heavy precipitation the ground water in the "confined wedge" rises rapidly, and since it is under hydrostatic pressure, the roadway is heaved upward. In addition to heaving the west-bound lanes, there is usually some encroachment of the cut slope into the ditchline (Figure 27).
